## Charles Dickens Museum, London

Artisan Plastercraft was commissioned to carry out inspections of the drawing room ceiling. The survey was completed by our team in February 2016.

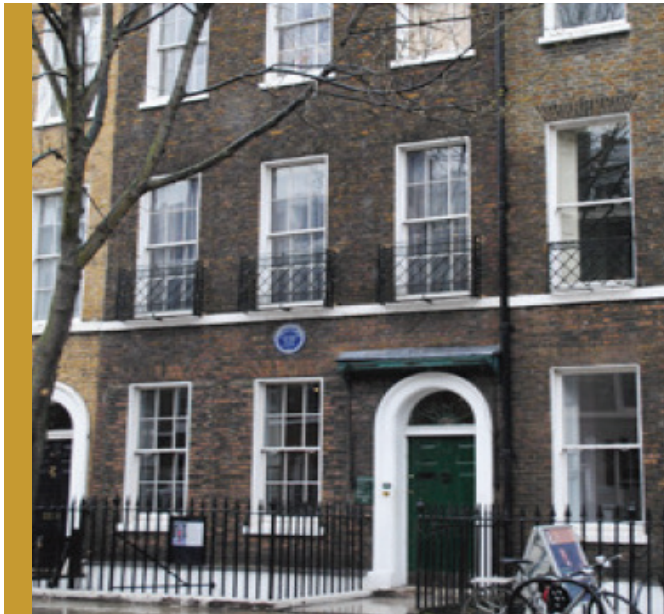
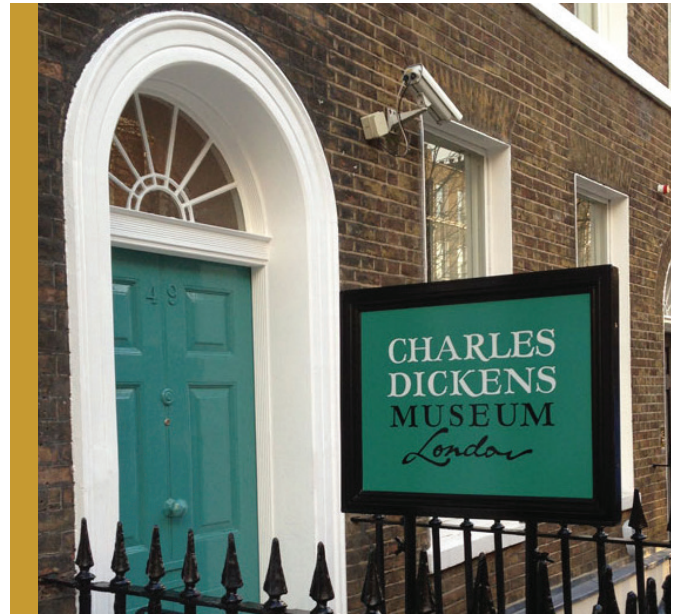
- Inspect and ascertain the extent and condition of the remaining lath and plaster ceilings where possible.
- To make recommendations on what areas of the ceiling soffits could reasonably be secured.
- Where it was thought that the existing ceilings could be reasonably retained and secured, recommend a suitable method of securing ceilings/mouldings in keeping with the character and Listed status of the property.

**Our solution:** We advised that where ceilings had evidence of missing key and delamination they required securing with a combination of blanket wadding and stainless steel screws and washers using our system of stabilisation.

The process involves holes being drilled and countersunk into the face of the ceiling. Stainless steel screws and washers are then screwed into the recess to find the timber joists above. The spacing of holes will vary depending on the joists, relief enrichments and the condition of the ceiling. All holes are then filled with a patch of metal gauze and a mixture of lime /gypsum plaster and then made good, matching the original finish to ensure they are no longer visible.
